3 WEST OF US 83 NORTH

IDENTIFICATION	
(1) State Names	North Dakota
(8) Structure Number	0094-156.609
(5) Inventory Route	00094
(2) Highway Agency District	61
(3) County Code	Morton, North Dakota

(4) Place Code	7200
(6) Features Intersected	MISSOURI RIVER
(7) Facility Carried	INTERSTATE 94
(9) Location	3 WEST OF US 83 NORTH
(11) Mile Point	156.576 mi

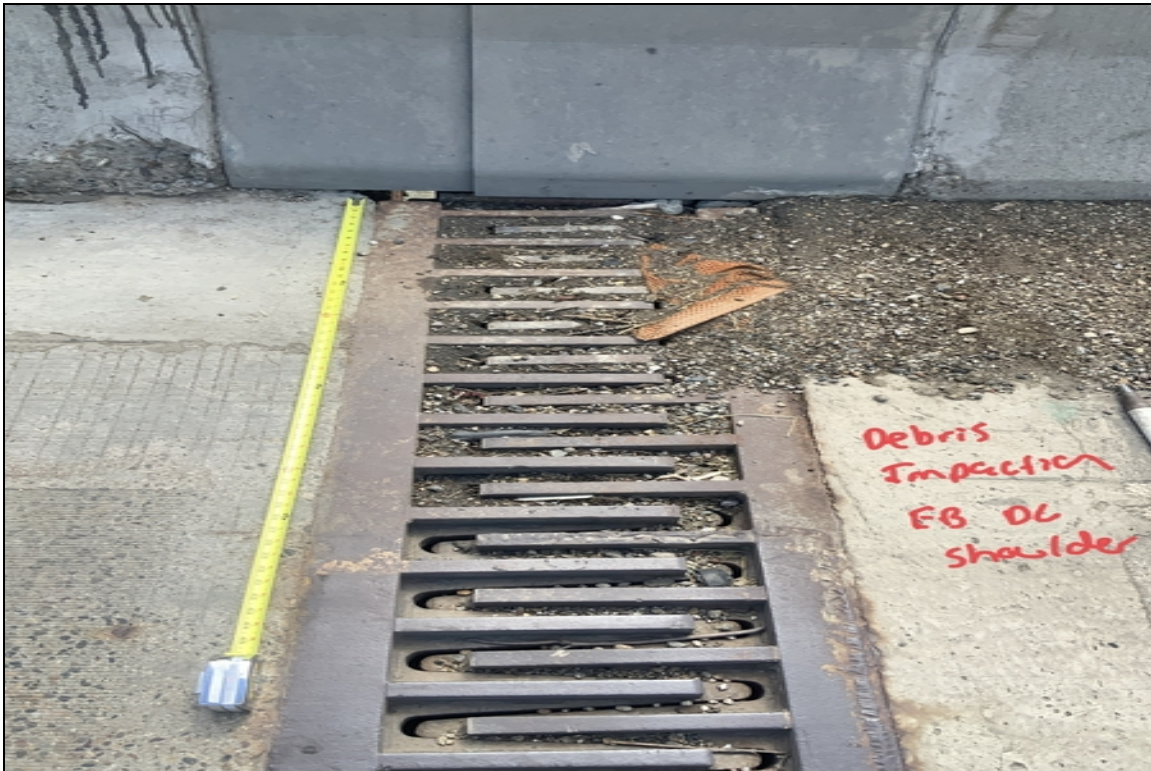
Facing South and Downward. Debris Impaction to Pier 2 along EB DL South Gutter Line.

Recommendation to flush Gutter Lines. Pier 2 and Pier 6 with debris filling up in both Expansion Joints. Recommendation to Flush out the Joints. Recommendation to clean out drainage systems. Sediment and Aggregate Buildup along WB and EB DL Gutter Lines.

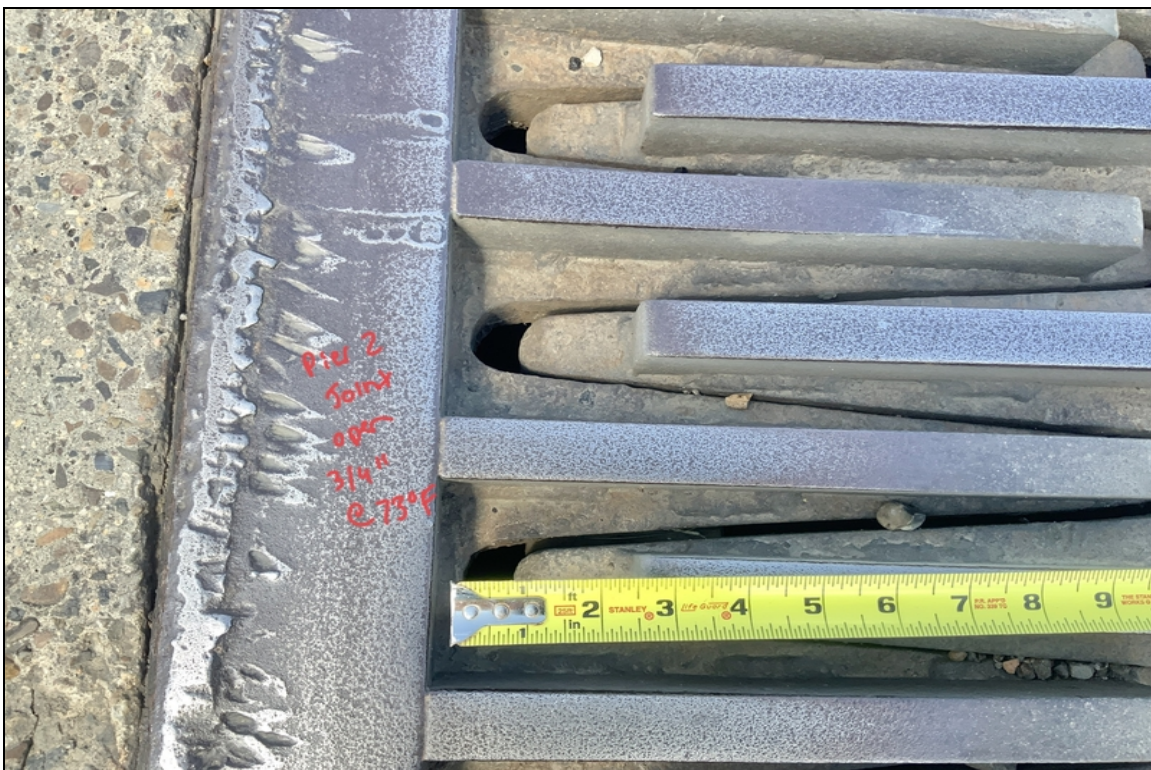
Facing North and Downward. Pier 2 Expansion Joint open 3/4" at 73 Degrees F.

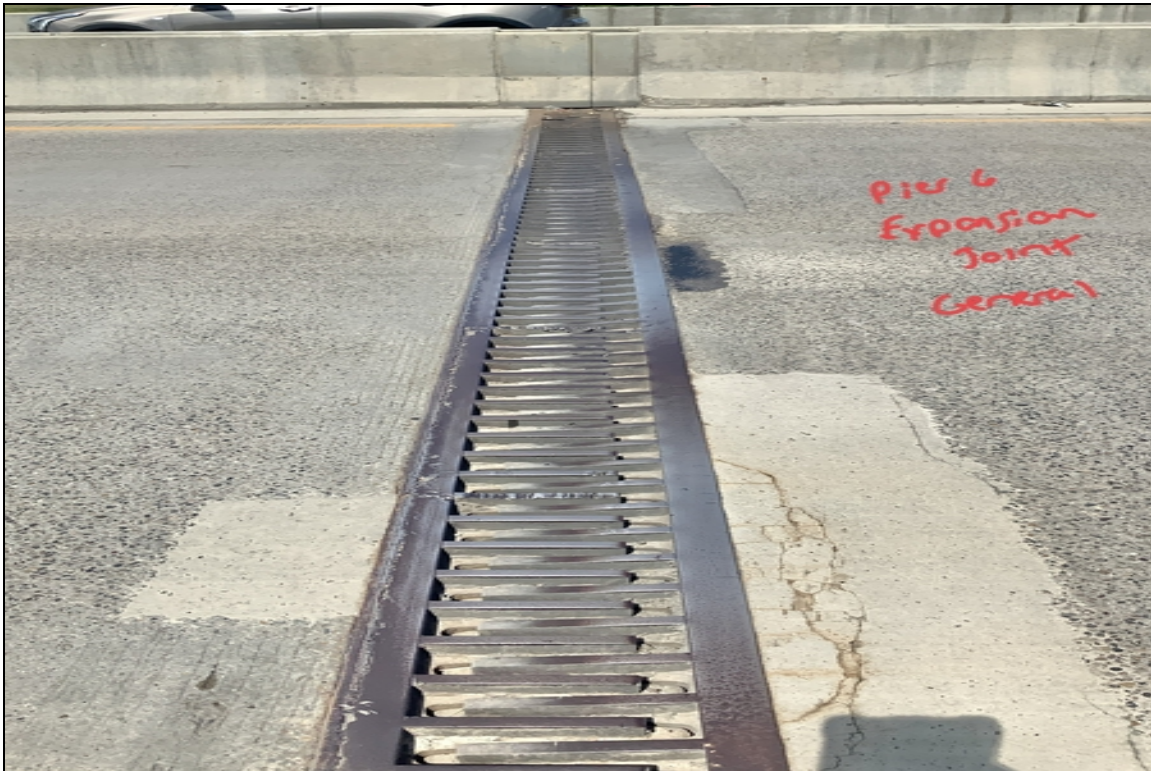
Facing North and Downward. General View of Pier 6 Expansion Joint EB I-94.

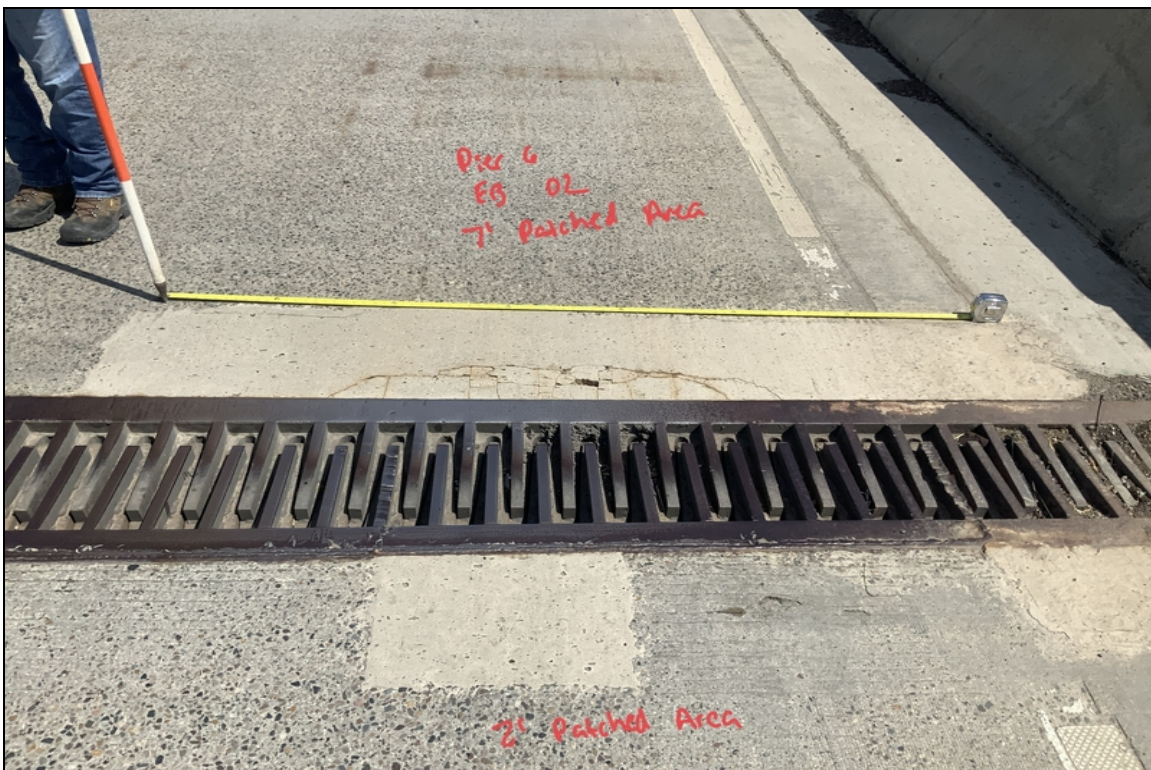
Facing East and Downward. Header Patched areas along EB DL at Pier 6.

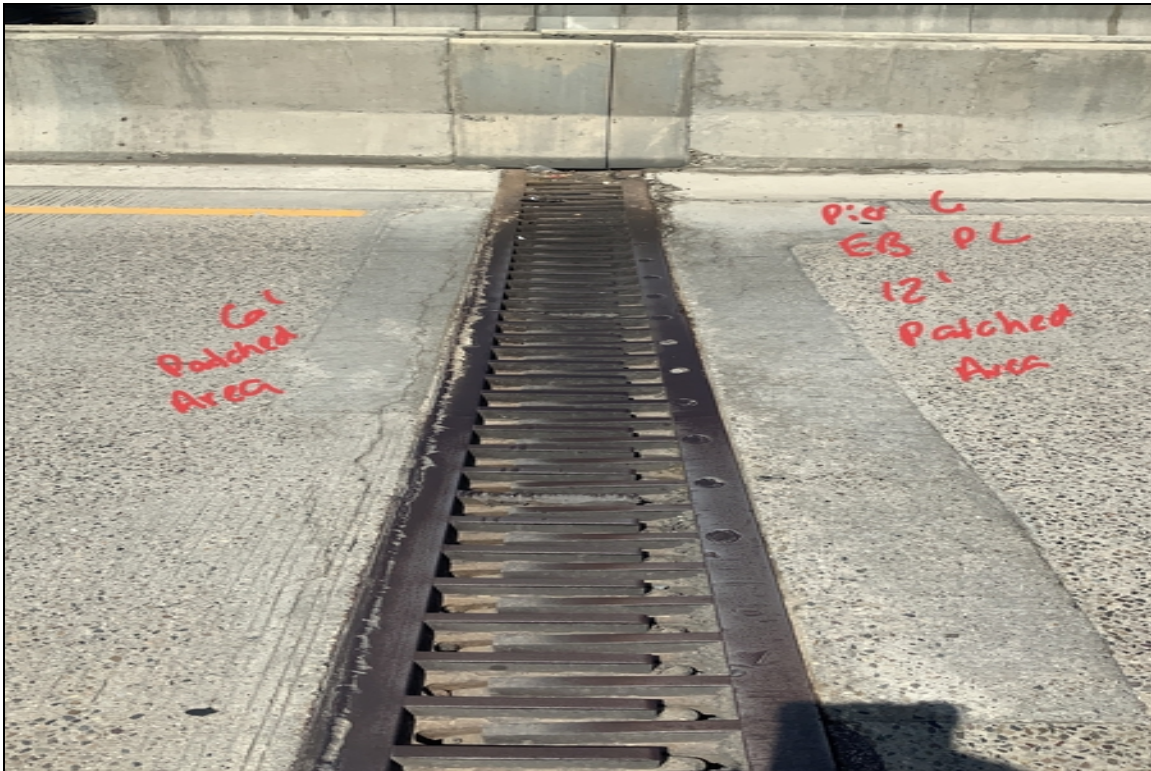
Facing North and Downward. Header Patched areas along Pier 6 Expansion Joint in EB PL.

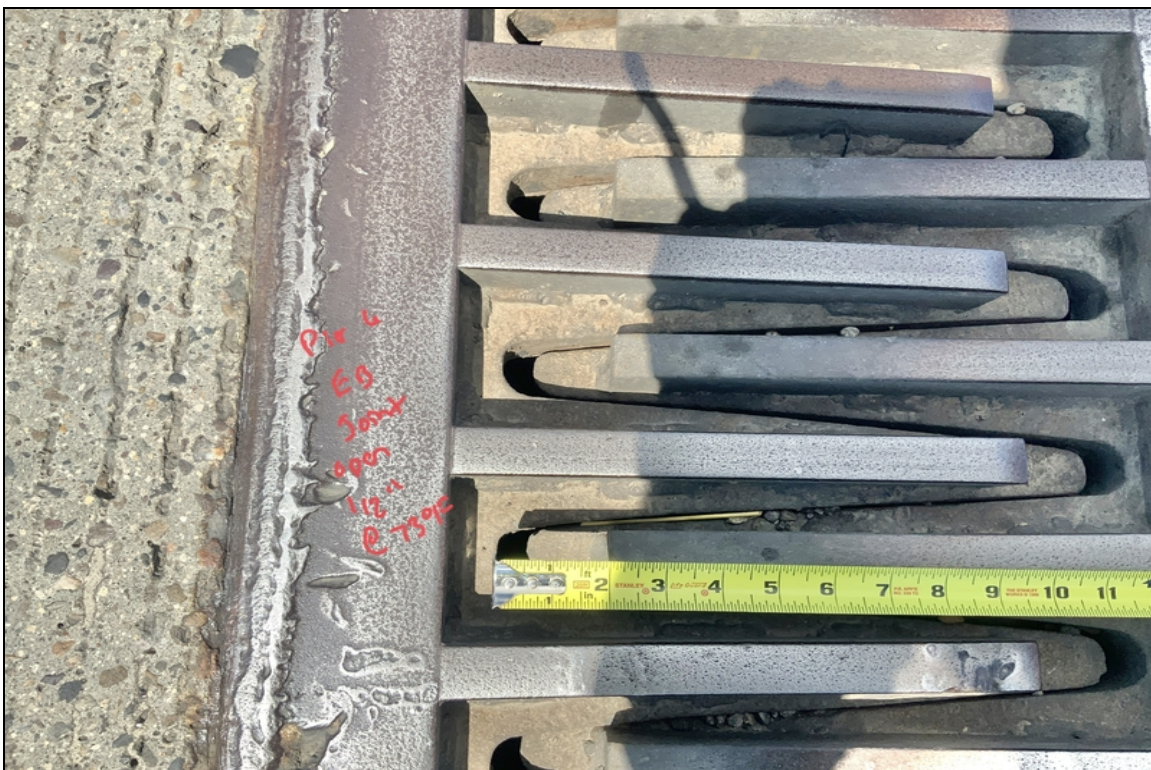
Facing North and Downward. Pier 6 Expansion Joint opening of 1/2" at 73 Degrees F.

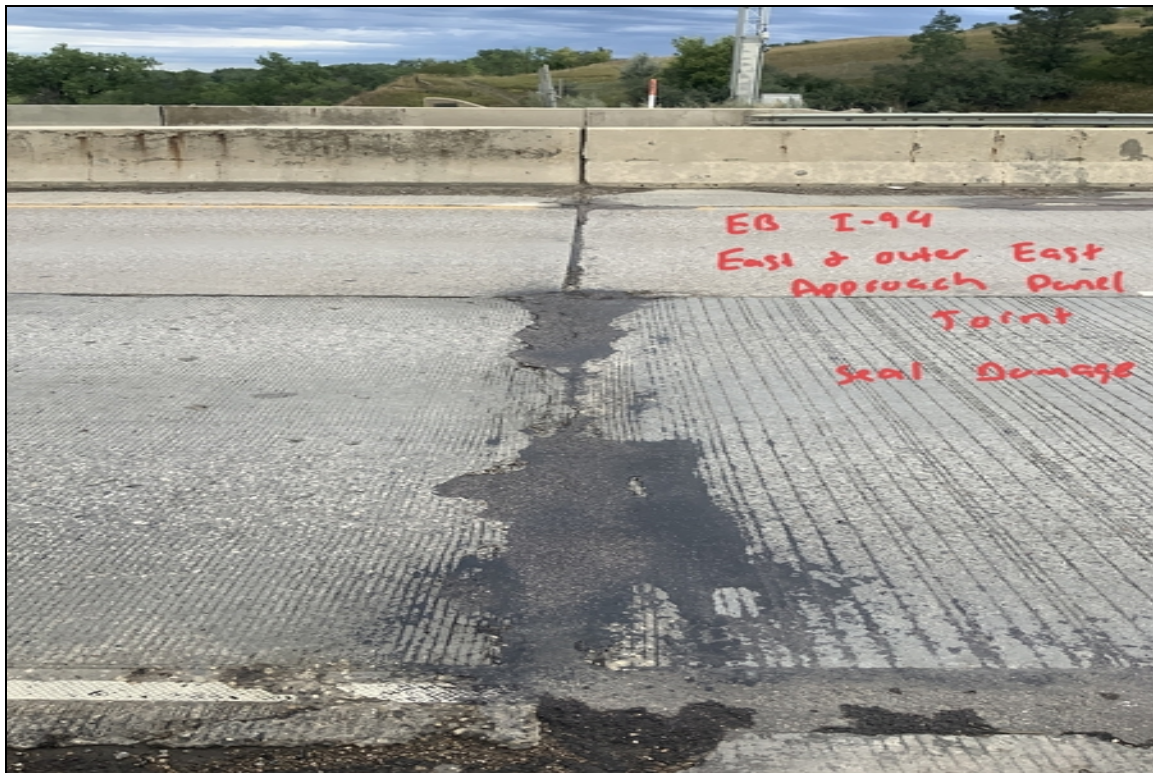
Facing North. EB I-94 East Approach And Outer Approach Transverse joint with no sealant.

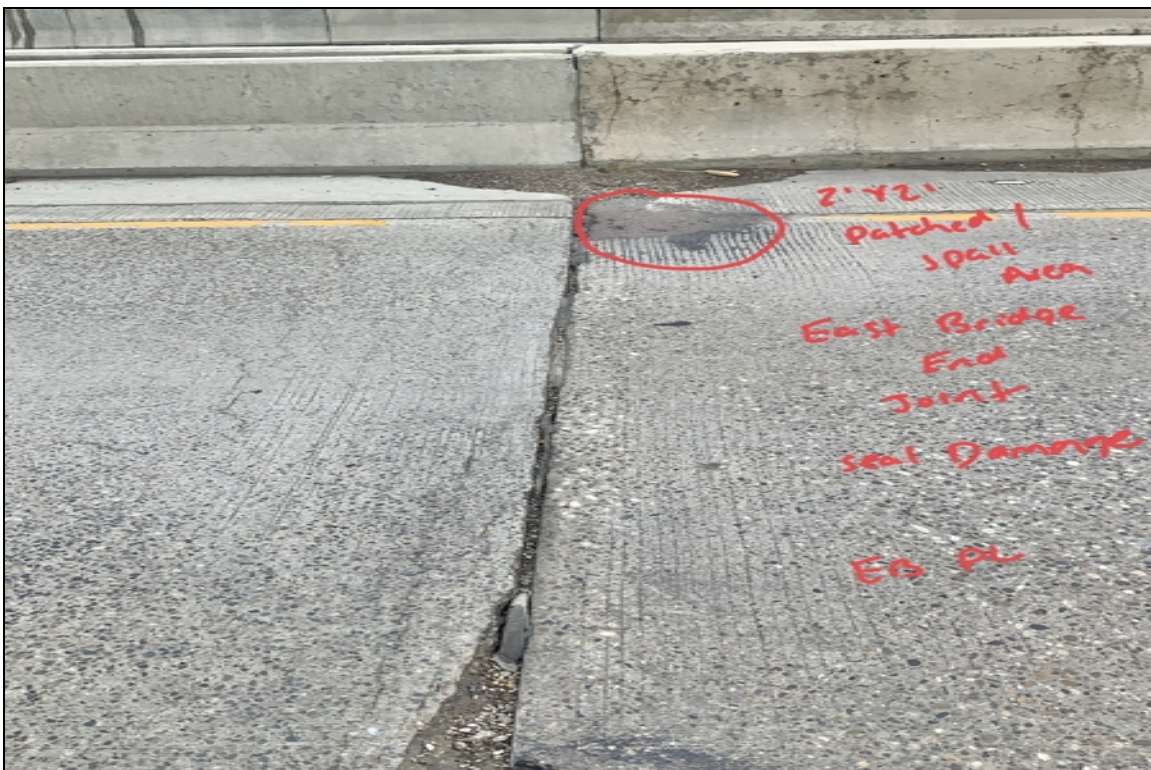
Facing North and Downward. EB PL Bridge Joint with seal damage causing failure of adhesion and debris filtering in.

Recommendation to Clean and reseal joints.

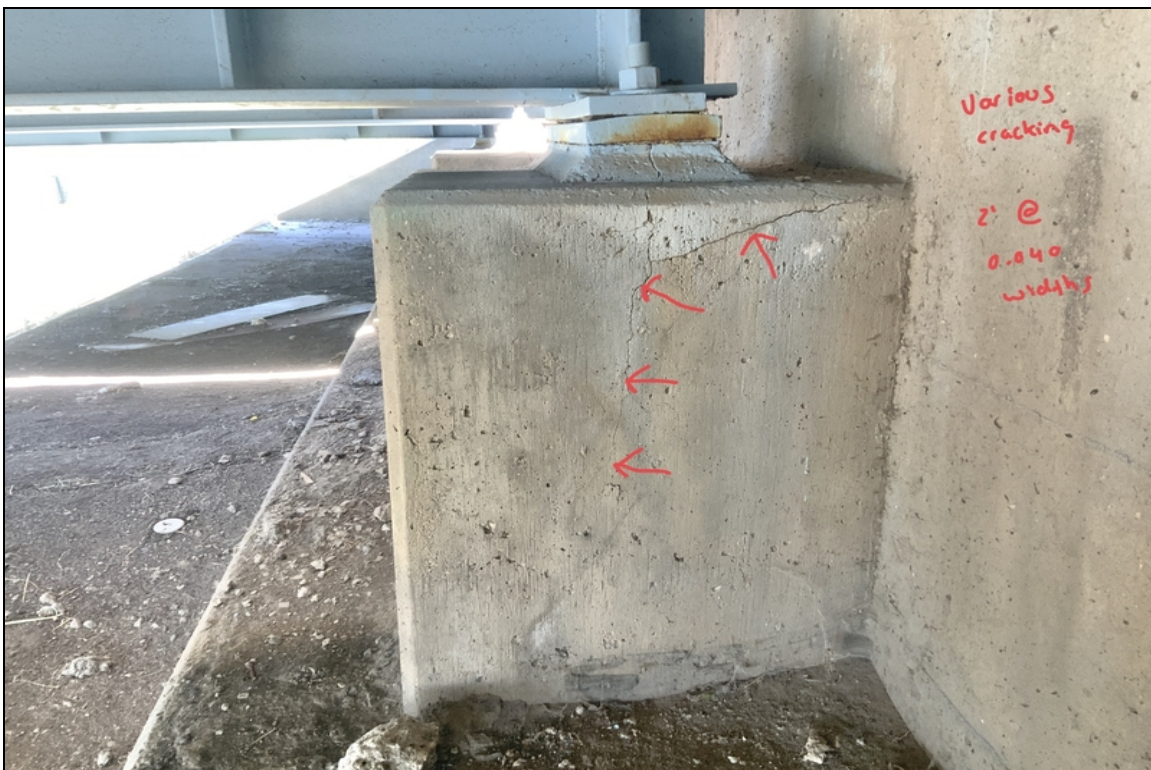
Facing North. Various cracking to EB I-94 Bearing 1 at East Abutment.

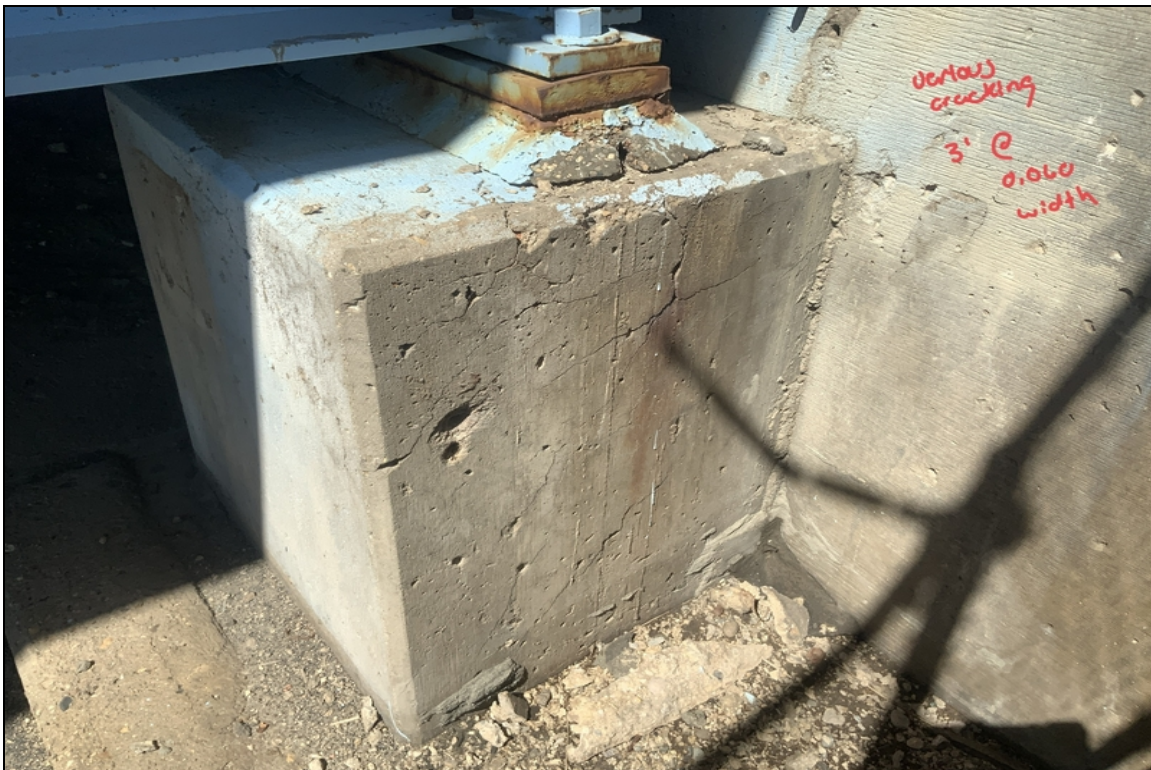
Facing NE and Downward. Various Cracking to EB I-94 Bearing 2 at East Abutment.

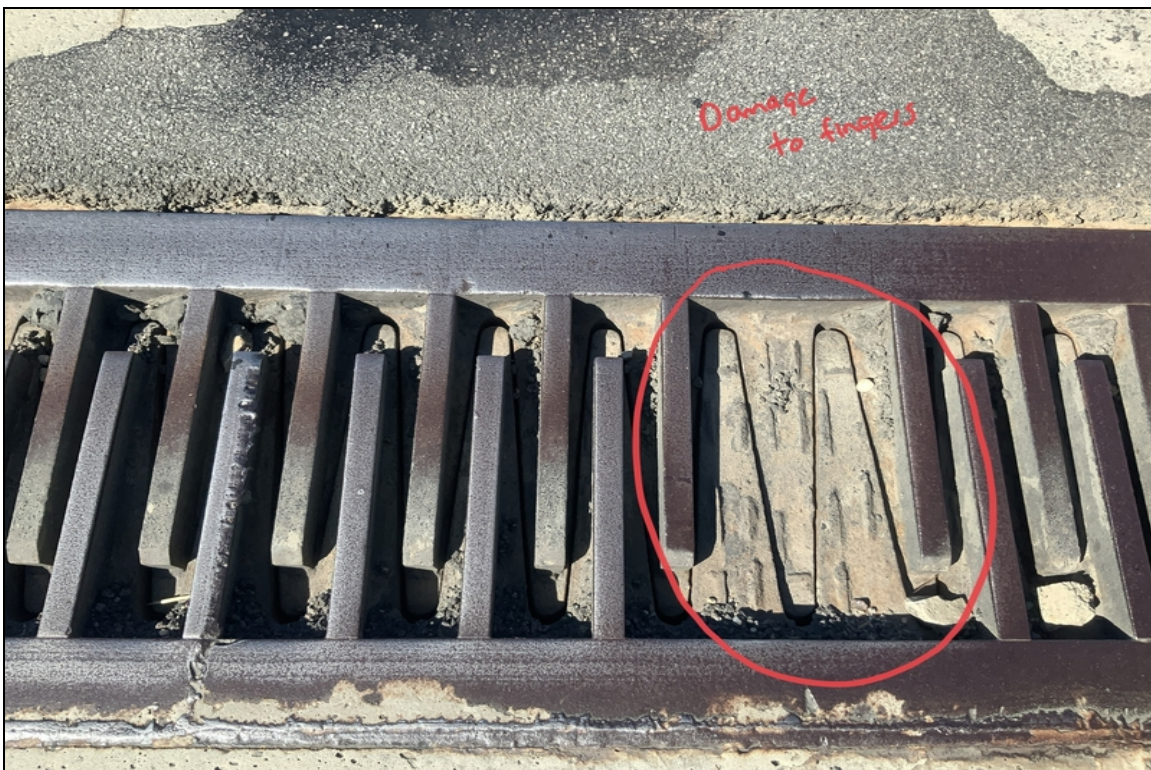
Facing West and Downward. Damage to top portion of Fingers in the WB DL.

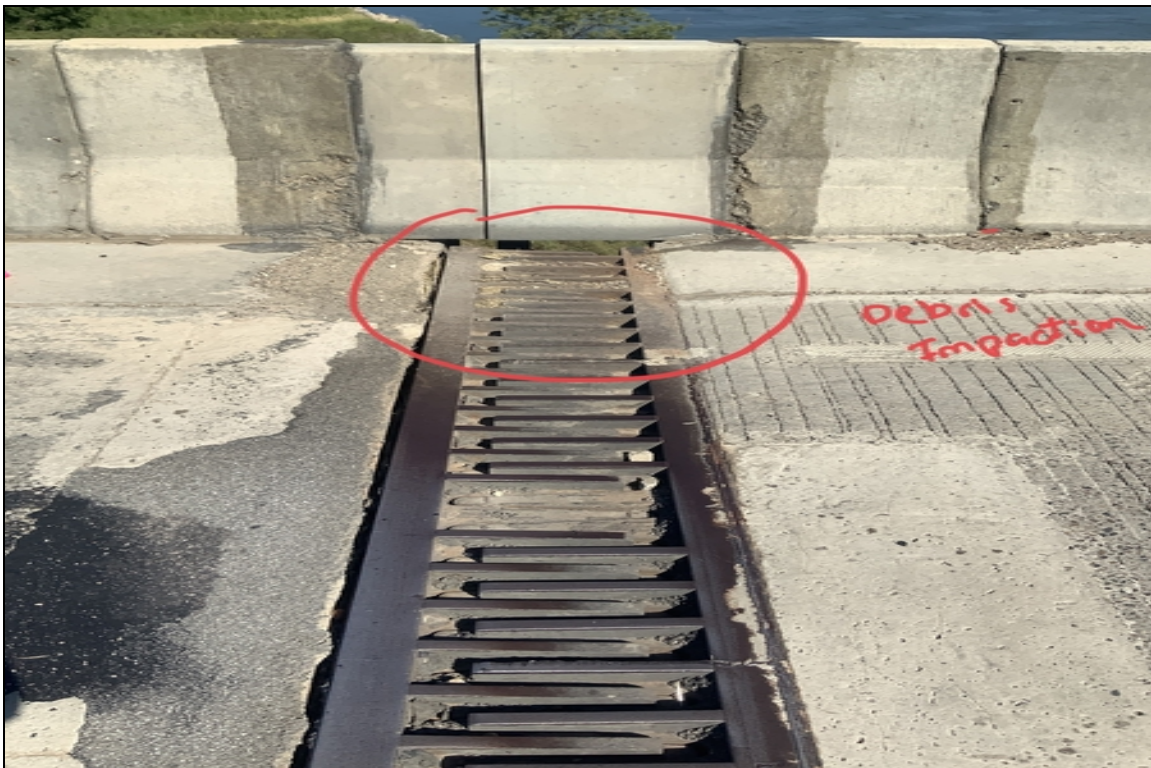
Facing North and Downward. Debris Impactation to Gutter Line of Expansion Joint over Pier 2.

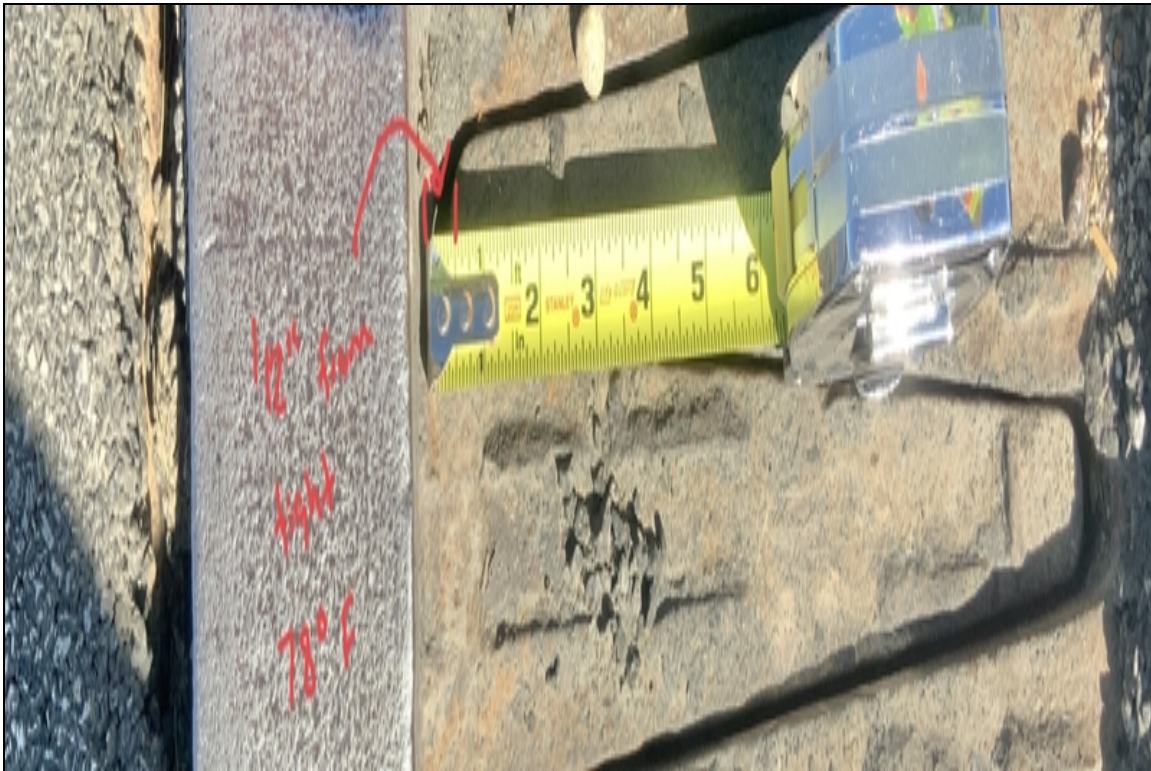
Facing North and Downward. Attempting to show Pier 2 opening between the fingers at 1/2" at 78 Degrees F.

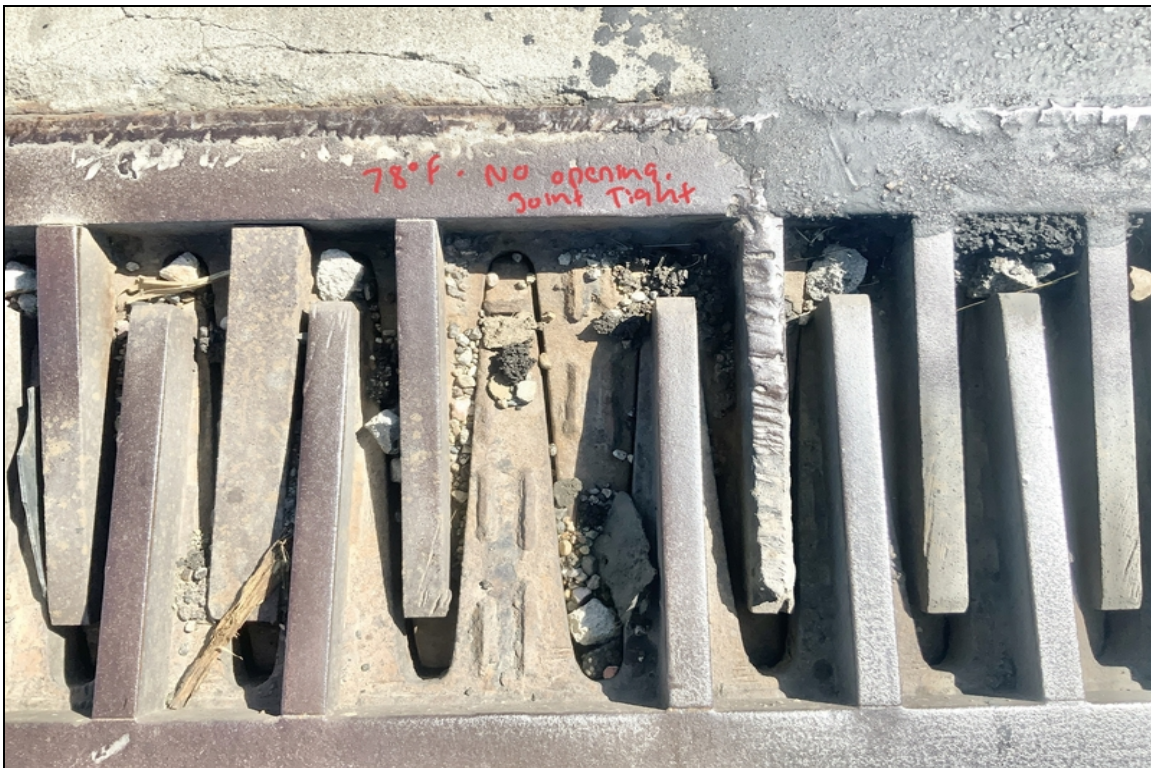
Facing West and Downward. Joint is tight.

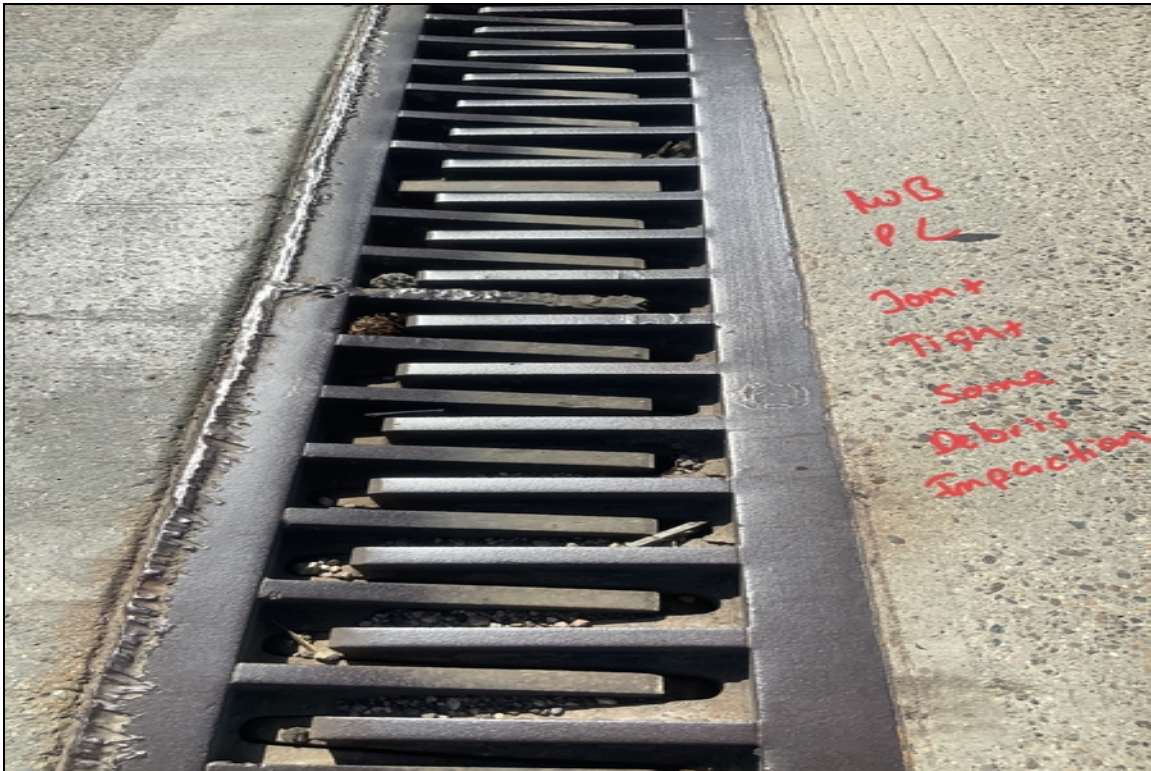
Facing South and Downward. Some Debris Impaction throughout Pier 6 Joint.

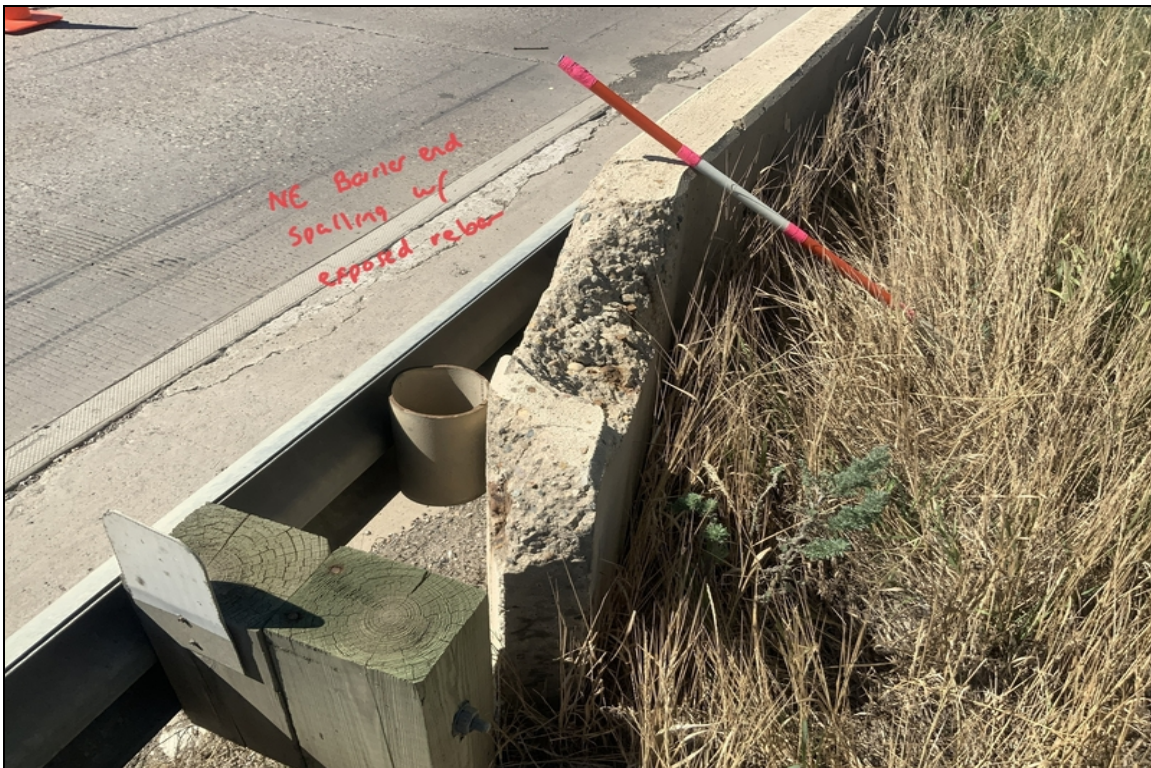
Facing SW. Spalling with exposed rebar to NE Barrier end.

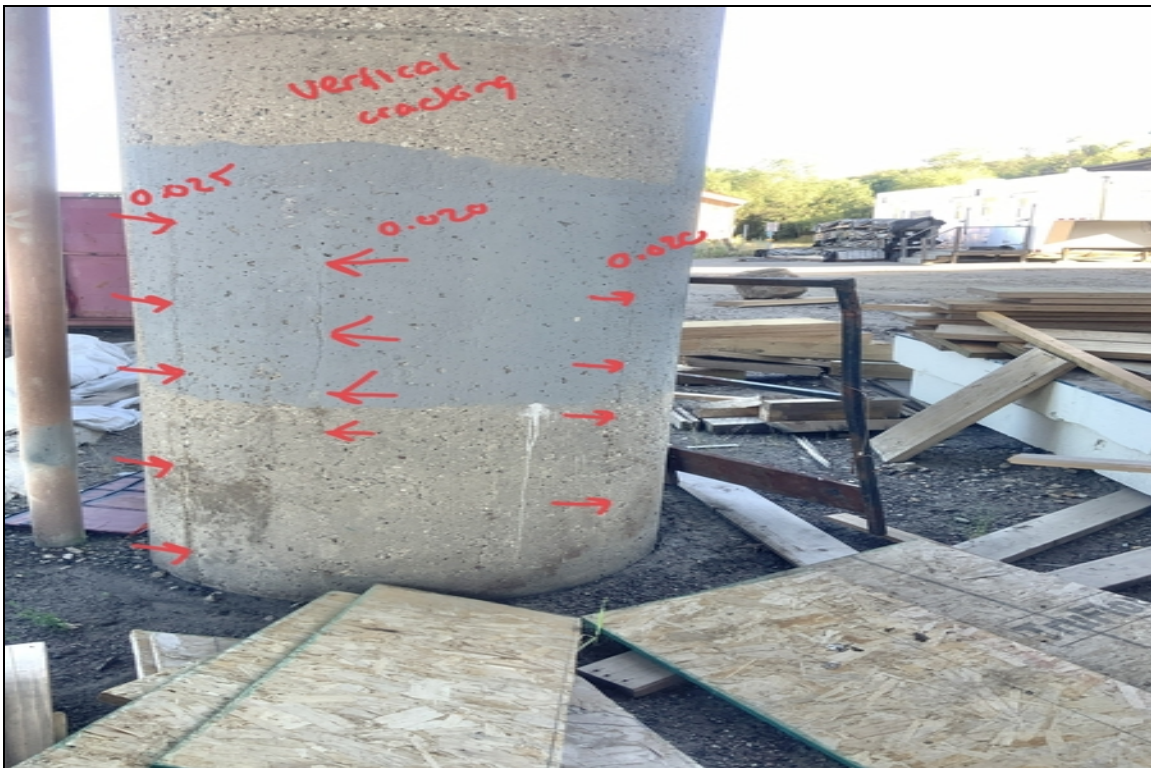
Facing North. Vertical Cracking Pier 6 Column 1.

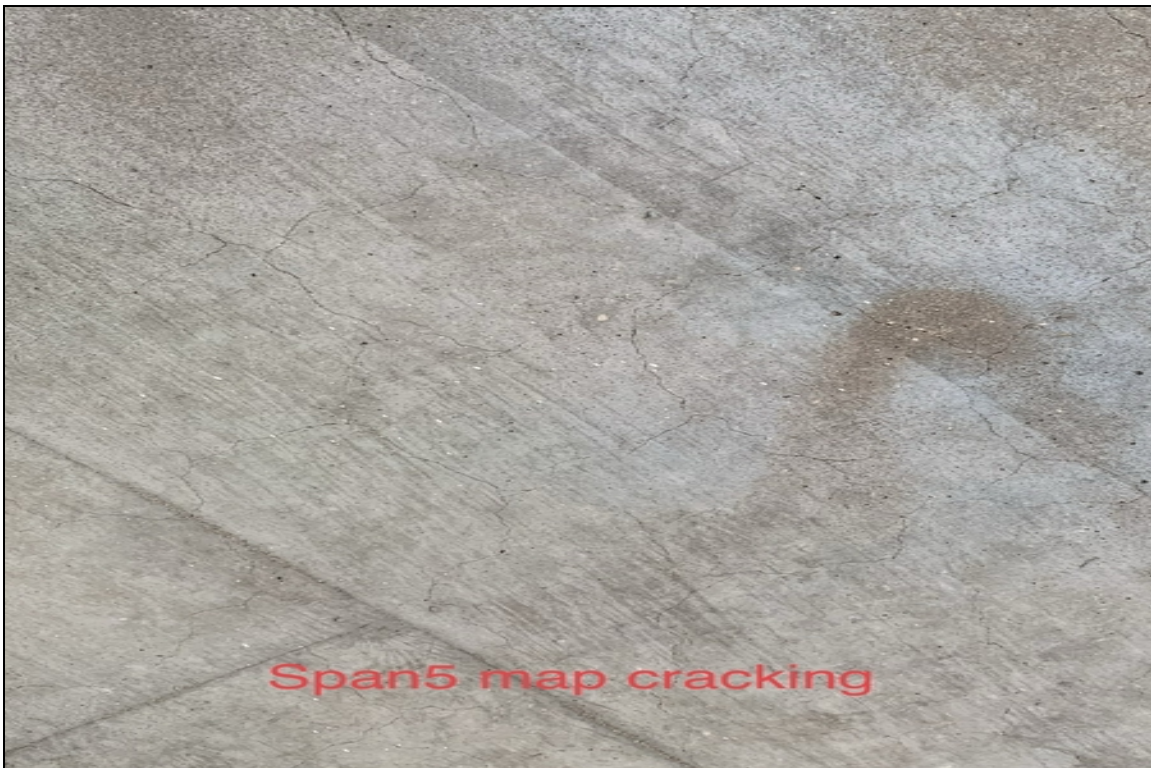
WB span 5 under side deck map cracking

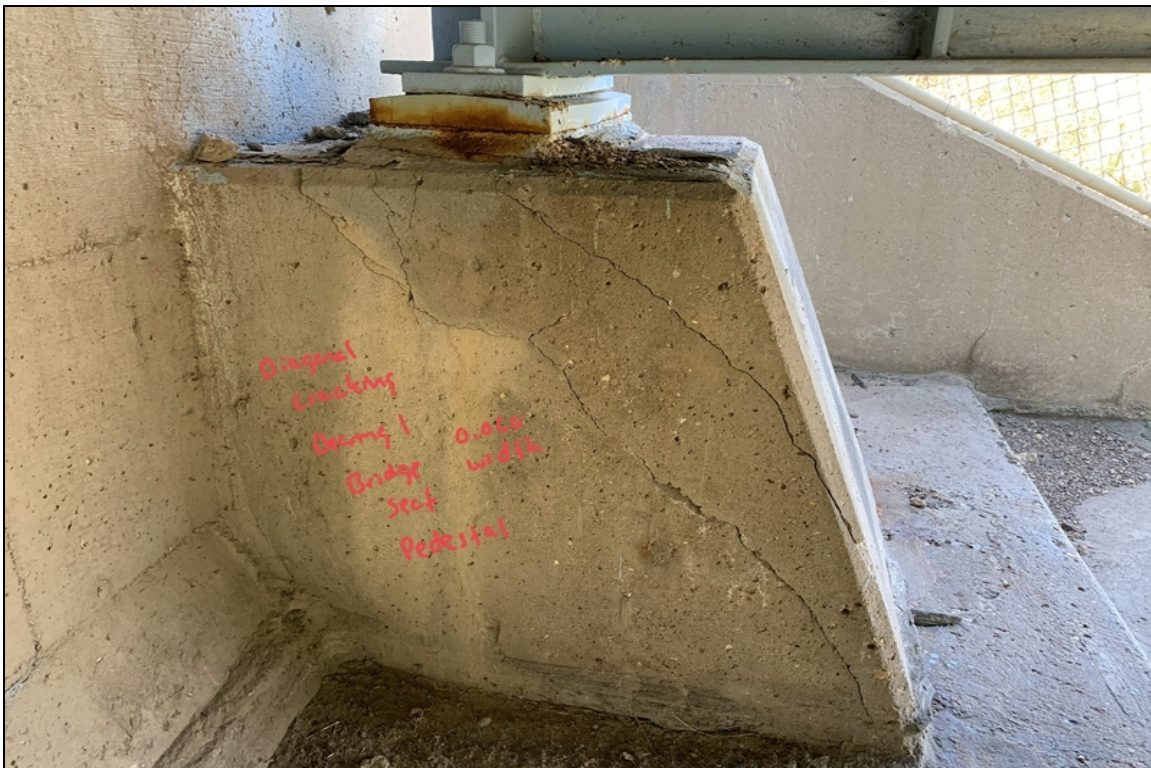
Facing North. Various cracking to WB I-94 Bearing 1 Bridge Seat Pedestal at West Abutment.

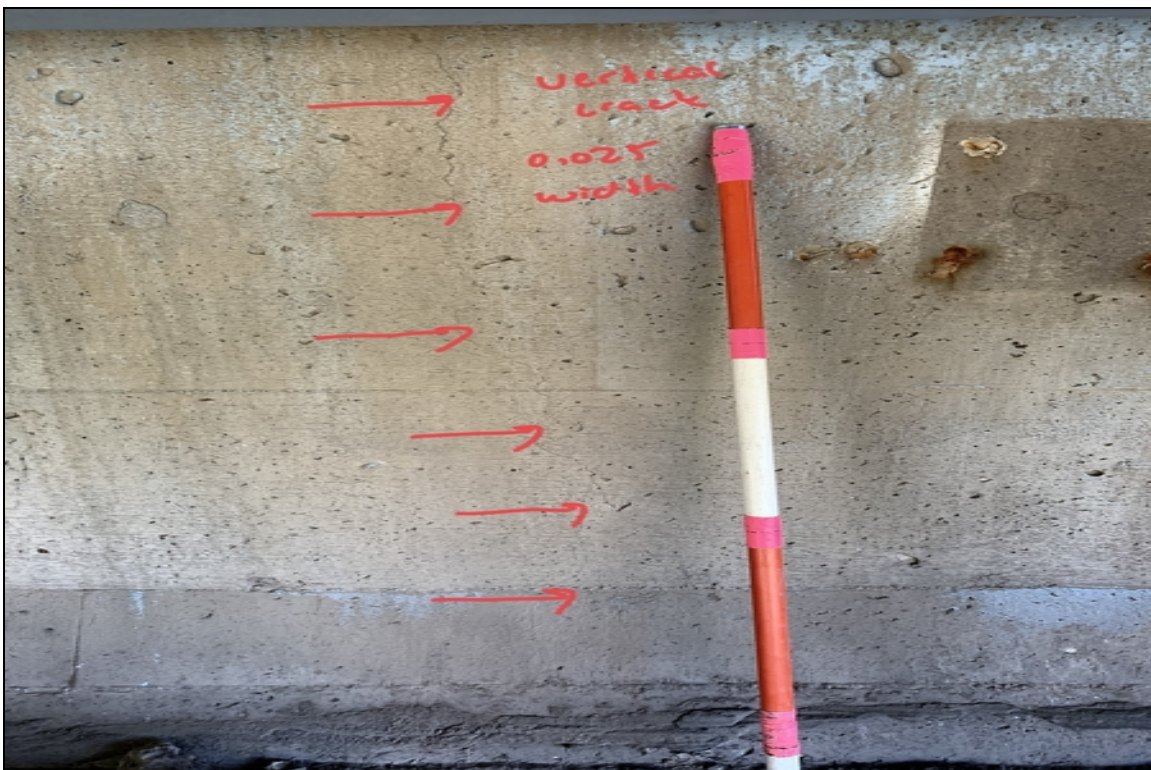
Facing West. Vertical Cracking to West Abutment Backwall South of WB I-94 Girder 1.

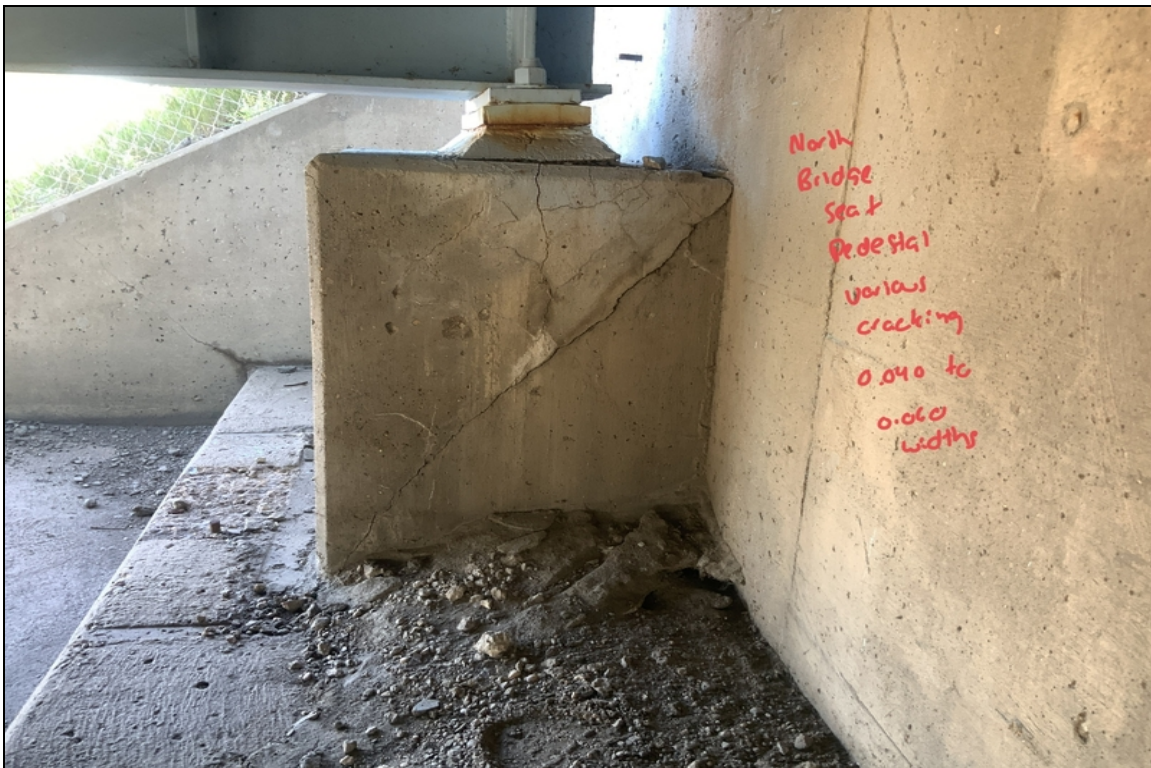
Facing North. Various cracking to WB I-94 Bearing 1 Bridge Seat Pedestal.

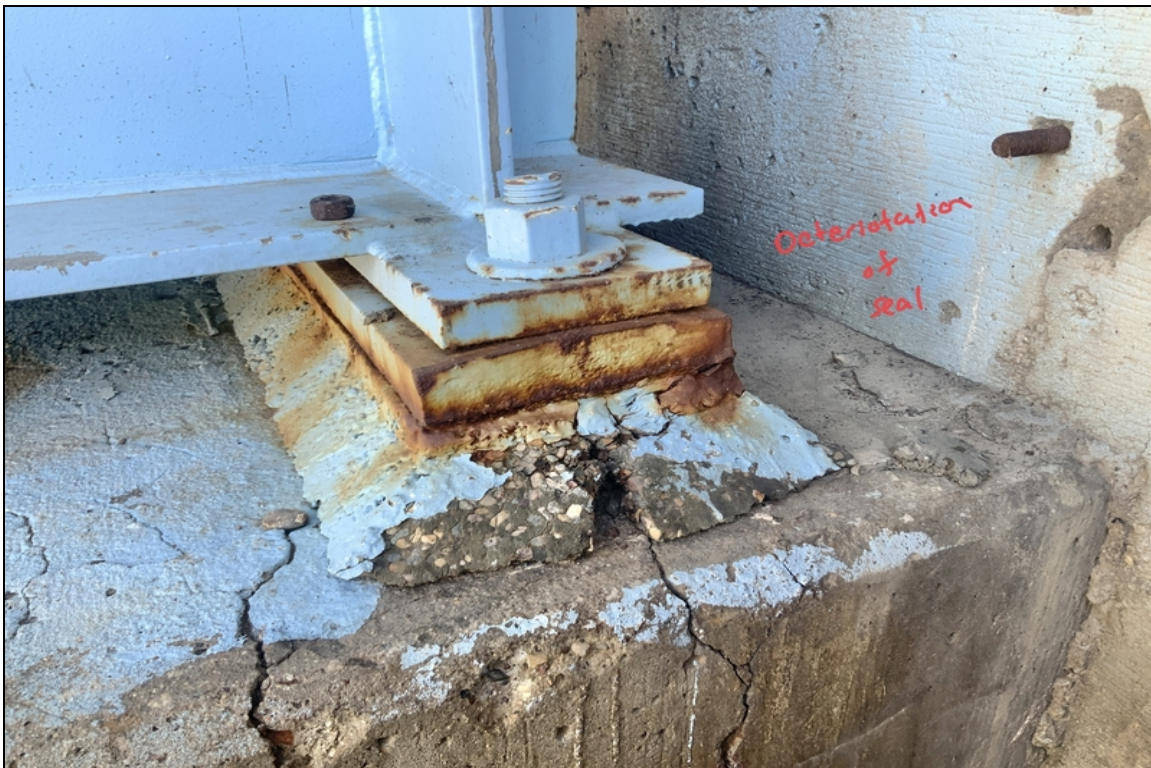
Facing North. Deterioration of EB I-94 Bearing 2 seal.

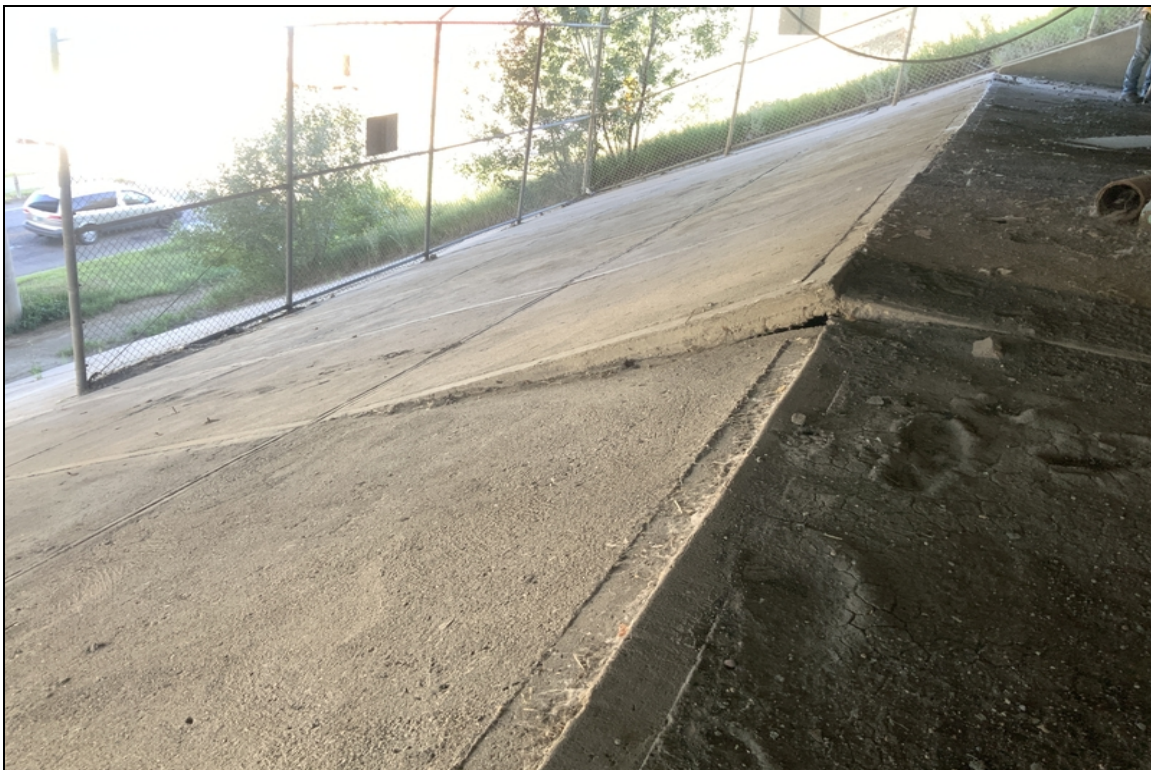
Facing North. Some Buckling of East Slope Protection at top Near Girder 3.

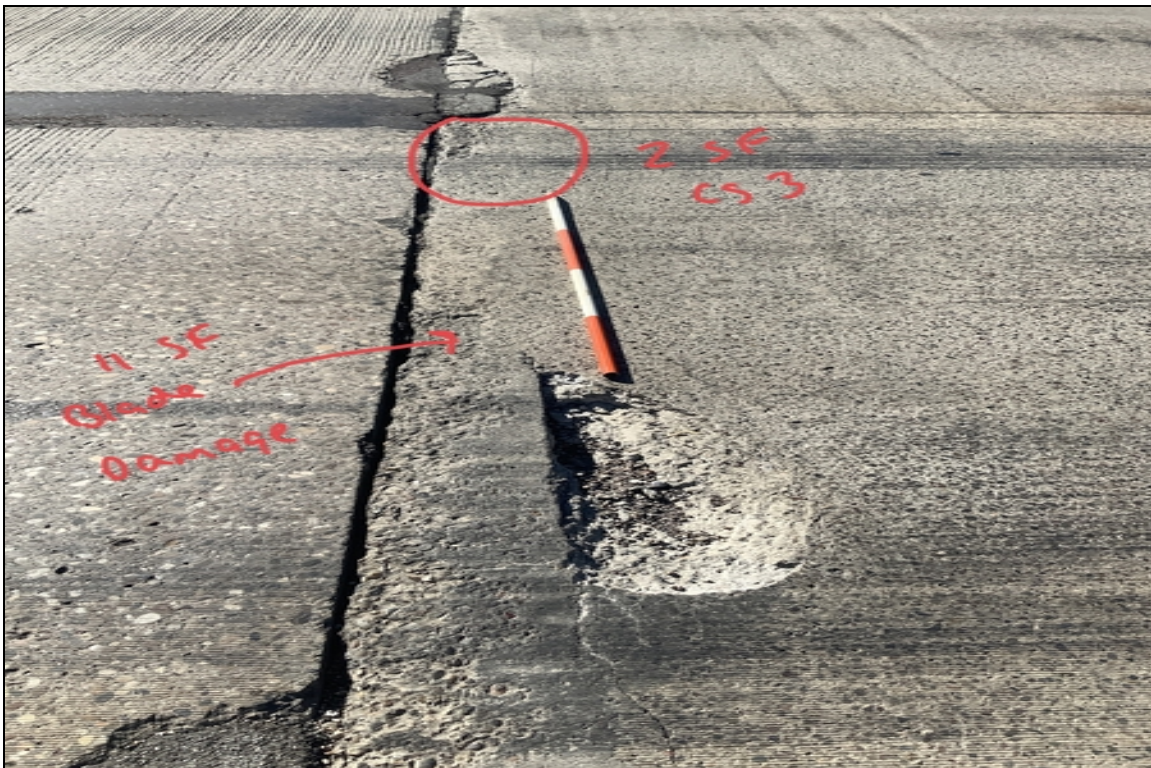
Facing South and Downward. Blade Damage across East End of Bridge Deck in the WB DL.

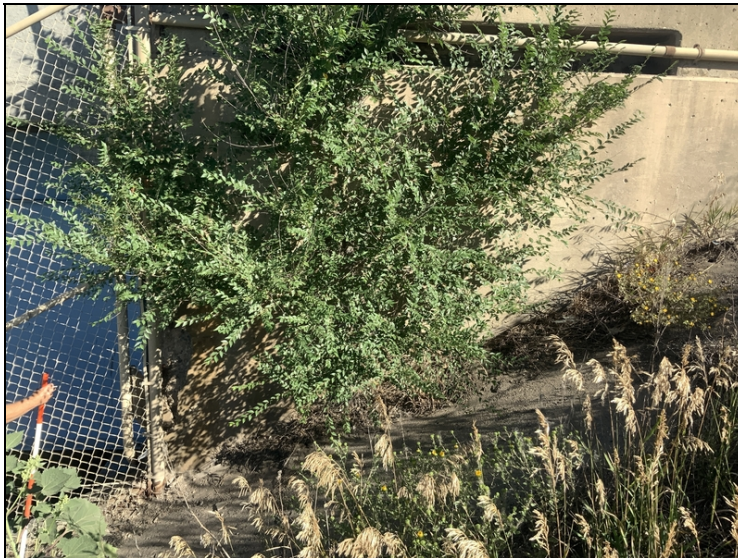
Facing North. Tree Growth along SE Wing.

Recommendation to remove.

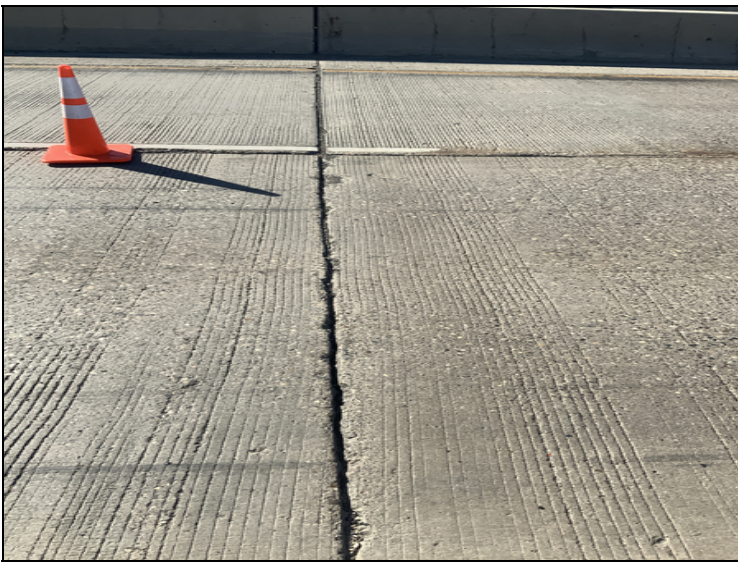
All Pourable Joint Sealant with seal damage with complete removal of sealant. . See Photos. 10August2020

Facing South and Downward. Seal Damage completely across Approach Panel Joint.

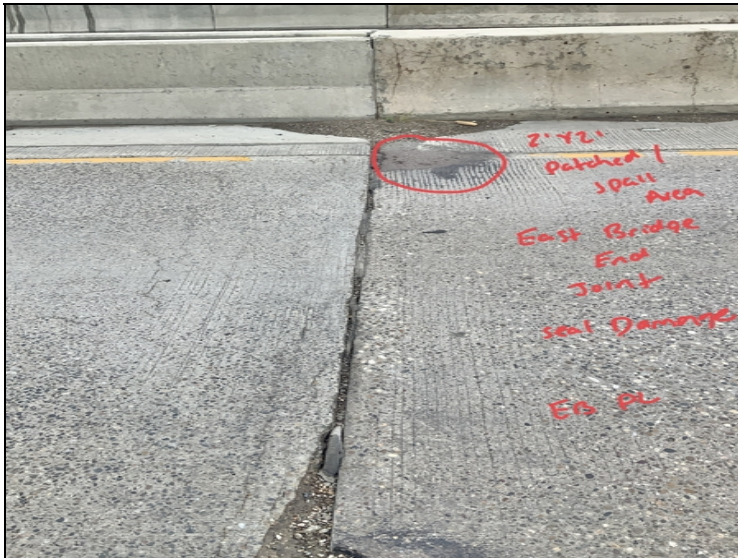
Facing North and Downward. EB PL Bridge Joint with seal damage causing failure of adhesion and debris filtering in.
